APPLICATION OF ELECTRICAL RESISTIVITY TOMOGRAPHY TO INVESTIGATING GEOLOGICAL CAUSES OF ROAD FAILURE IN TARABA STATE, NIGERIA

¹Weltime O. Medjor, *²Kanu Maxwell Obia and ²Simon Solomon

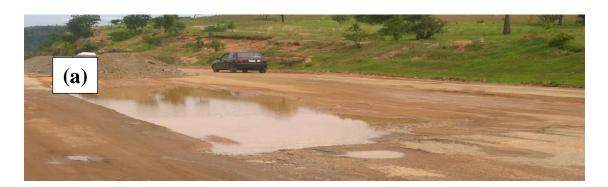
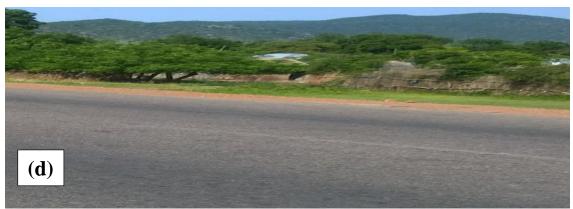
Fig. 3. Condition of the Investigated Jalingo – Zing Road. (a) – (c) are failed portions located at Lankaviri 2, Lankaviri 1 (near Custom office) and Pupule. (d) is a control road located at Mararaban Kunini

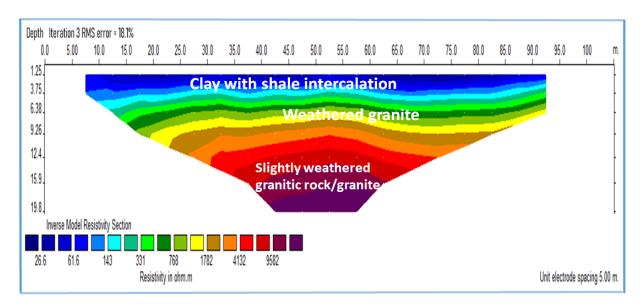
Fig. 4 ERT1 Lankaviri 1

The 2D inverted resistivity of all the profiles are presented in Figs. 4 to Fig.13. The pseudo sections reveal features that may be responsible for the cause of road failure. Fig.4 shows three conductive zones in the profile and low resistivity zone (deep blue) layer with resistivity between 26.6 and 61.6 Ω m across the entire profile at a depth of 3.75 m. Underlain this layer is a moderate resistivity zone (light green) with resistivity from 331 Ω m to 768 Ω m at a depth between 3.75 m and 9.26 m. This can be interpreted as weathered granite. Below this is a very high resistivity layer (yellow to pink) with resistivity from 1782 Ω m to 9582 Ω m at a depth between 9.26 m and 19.8 m.

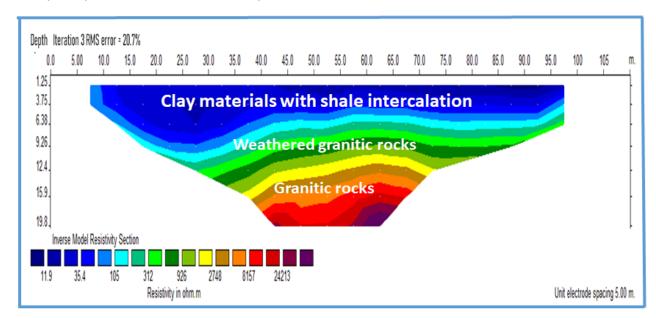
Fig. 5 ERT 2 Mararaban Zing

Fig.5 shows three pronounced zones across the profile with low resistivity zone (deep blue) with resistivity values between 11.9 and

35.4 Ωm across the entire profile at depths 9.26 m and 6.28 m. Below this layer is a moderate zone (light blue to yellow) with resistivity ranging 105 Ωm to 2748 Ωm at a depth between 9.26 m and 15.9 m and a high resistivity zone (red to pink) ranging from 8157 Ωm to 24213 Ωm at depths between 15.9 m and 19.8 m.

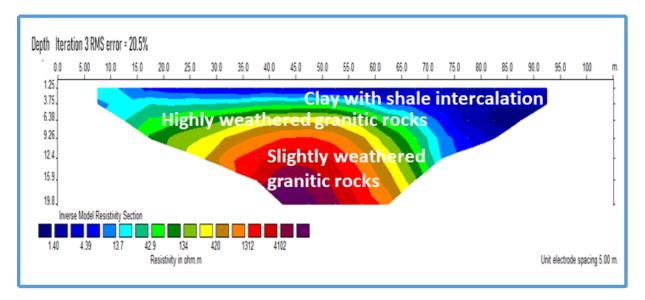
Fig. 6 ERT 3 Apawa

Fig.6 reveals three zones with low resistivity zone (deep blue) with resistivity values ranging from 1.40 to 4.39 Ωm occurring across the profile at depths 3.75m at surface points between 5.0 m and 60 m and at depth 12.4 m between the surface points 60.0 m and 95 m. Underlain this is a moderate resistivity zone (light blue to yellow) ranging from 14.0 Ωm to 420 Ωm and a high resistivity zone (red to pink) with resistivity ranging 1312 Ωm to 4102 Ωm at depths between 9.26 m and 19.8 m.

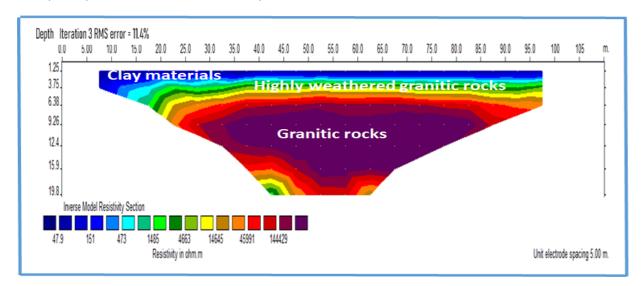
Fig.7 ERT 4 Mararaban Kunini (Control)

Fig.7 shows three conductive zones with low resistivity zone (deep blue) less than having values from 47.9 to 151 Ωm at a depth of 1.30 m across the entire profile. Below this layer is a high zone (light blue to yellow) with resistivity ranging from 473 Ωm to 1465 Ωm at depth between 1.30m and 6.38m. Underlain this layer is a very high resistivity zone (red to pink) with resistivity ranging from 45991 Ωm to 144429 Ωm at depths between 6.38 m and 19.8 m.

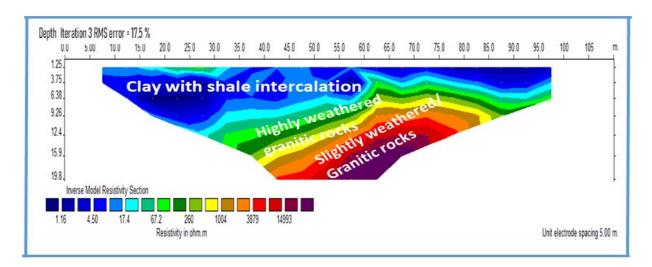
Fig. 8 ERT 5 Lankaviri 2

In Fig.8, three pronounced zones with very low resistivity zone (deep blue) with resistivity varying from 1.16 to 4.50 Ωm across the top of the profile at depths 12.4 m, 9.26 m and 6.38 m were revealed. Under lain this is a low resistivity zone (light blue to lemon green) with resistivity ranging from 17 Ωm to 260 Ωm at depths between 12.4 m and 15.9 m, 6.38 m and 6.38 m and 9.26 m. And a high resistivity zone (yellow to pink) with resistivity ranging from 1004 Ωm to 14993 Ωm at depths between 15.9 m and 19.8 m, 12.4 m and 19.8 m.

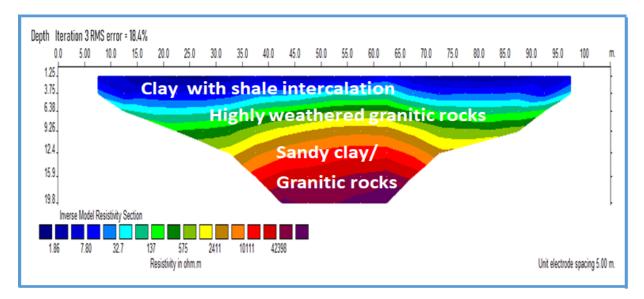
Fig. 9 ERT 6, Jimlari

Fig.9 shows three zones with very low resistivity (deep blue) with resistivity varying from 5.83 to $7.30~\Omega m$ at the surface points 5.0~m and 100.0~m at depths 1.25~m and 3.75~m. Underlain this is low resistivity zone (light blue to lemon) with resistivity ranging from 33~m

Ω m to 575 Ω m at depths between 3.75 m and 9.26 m. And a high resistivity zone (yellow to pink) with resistivity ranging from 2411 Ω m to 42398 Ω m at depths between 15.9 m and 19.8 m.

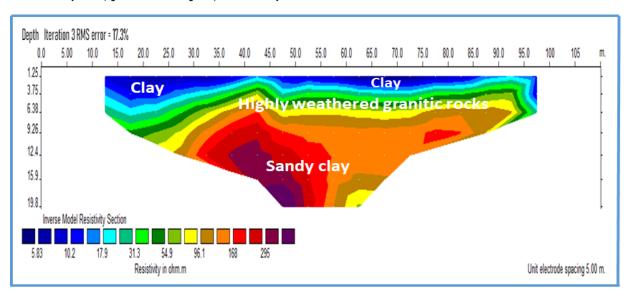
Fig.10 ERT 7 Appawa Gadda

ERT 7 (Fig. 10) reveals three resistive zones with a very low resistivity (deep blue) having resistivity varying from 5.83 to 10.20 Ω m at a depth of 3.75 m across the profile. Underlain this layer is a low resistivity zone (light blue to lemon green) with resistivity

ranging from 18 Ω m to 55 Ω m at depths between 6.38 m and 9.36 m. Below this is a high resistivity zone (yellow to pink) with resistivity ranging from 96 Ω m to 295 Ω m across the profile with depths between 9.26 m and 19.8 m.

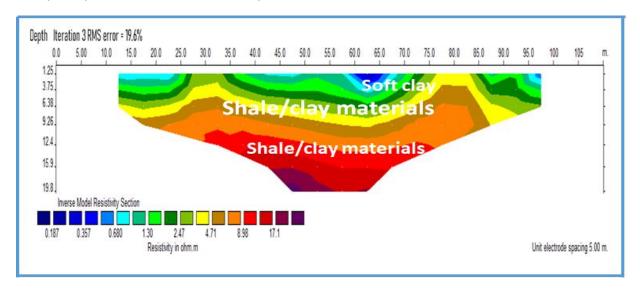
Fig. 11 ERT 8 Pupule Zing

ERT 8 (Fig. 11) shows two pronounced resistivity zones with very low patches of resistivity zone (deep/light blue) at surface points 10.0 m to 25.0 m, 40.0 m to 50.0 m and 58.0 m to 69.0 m with resistivity ranging from 0 Ωm to 1 Ωm . Below this zone is a low resistivity zone (lemon/yellow colour) with resistivity values ranging from 1 Ωm to 3 Ωm . Underlain this zone is a moderate zone (red/pink) with resistivity ranging from 9 Ωm to 17 Ωm .

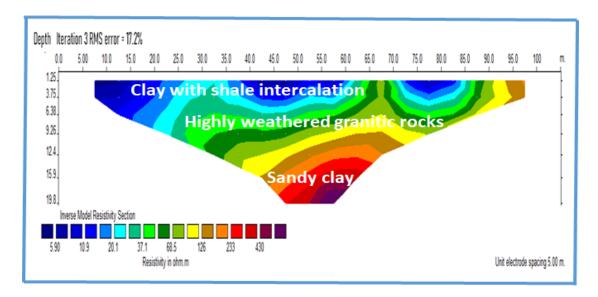
Fig. 12 ERT 9 Zing Town by College of Education

Fig.12 shows low resistivity values (deep blue) with resistivity

varying from 5.90 to 20.1 Ωm at surface points 5.0 m and 60.0 m with depths 9.0 m and 6.38 m between surface points 70.0 and 85.0 m at depth 5.0 m. This can be interpreted as clay with shale intercalation. Beneath this layer is moderate resistivity zone (lemon colour) with resistivity values ranging from 37-69 Ωm with a portion at surface points between 63.0 m and 70.0 m. Underlain this layer is a high resistivity zone with resistivity ranging from 126 Ωm to 430 Ωm .

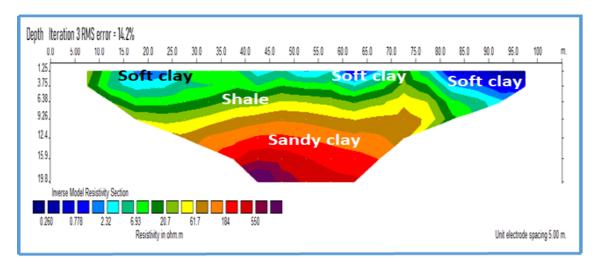
Fig. 13 ERT 10 Zing Town by immigration office

Fig. 13 displays patches of very low resistivity zone (deep blue) at surface points between 15.0 m -25.0 m, 40.0 m-70.0 and 77.0 m-100 m. In between and beneath this layer is low resistivity layer (lemon colour) with resistivity ranging from 6 Ωm to 21 Ωm . Underneath this layer is moderate resistivity zone (yellow to pink) with resistivity values ranging from 60 Ωm to 550 Ωm .

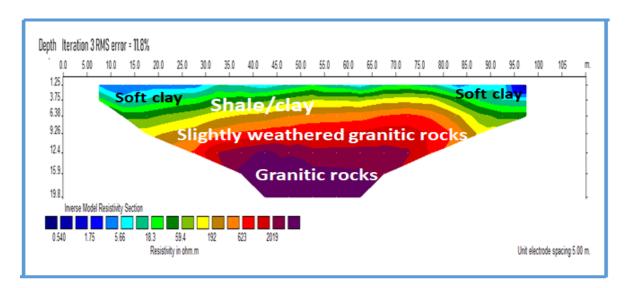
Fig. 14 Zing road after PHC ERT 11 (Control)

Fig. 14 shows a very low resistivity zone (blue) with patches at

surface 5.0 m to 30.0 m and 80 m to 100 m with resistivity ranging from 0 - 6 Ωm . In between and beneath this layer is a low resistivity zone (lemon colour) with resistivity ranging from18.0 Ωm to 59 Ωm at depths 9.0 m and 6.0 m. Underlain this layer is a high resistivity zone (yellow to pink) with resistivity values ranging from 192 Ωm to 2019 Ωm .
